(1984) - First International Conference on Case
Histories in Geotechnical Engineering

Repair and Replacement of Acid-Damaged Piles

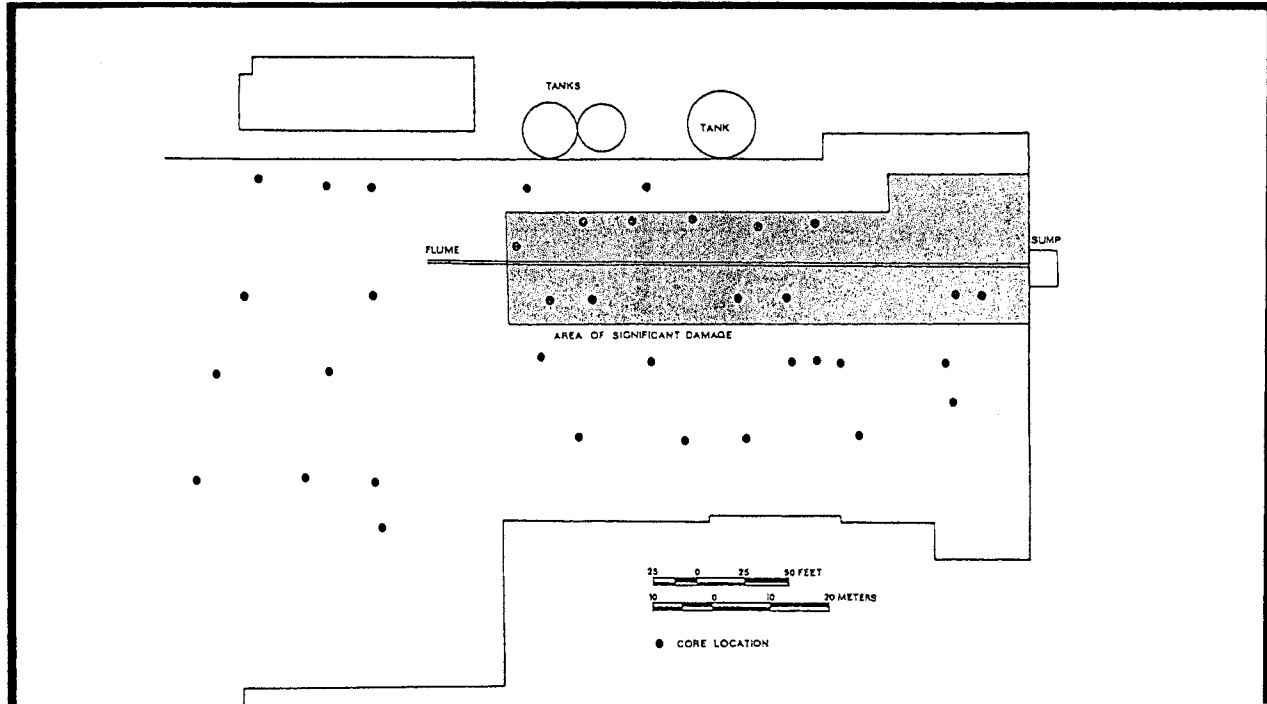
FIGURE 1

As a result of this initial investigation, underpinning of columns in the area of known damage was begun immediately, and further investigation was simultaneously undertaken to better define the extent of the problem. An additional 33 piles were cored. Core locations are shown on Figure 1.

On the basis of all cores and pits described above, the limits of the damaged area were defined with reasonable confidence (see Figure 1). The area of damage had dimensions of approximately 60 by 290 ft (18 by 88 m), centered longitudinally on an acid flume.

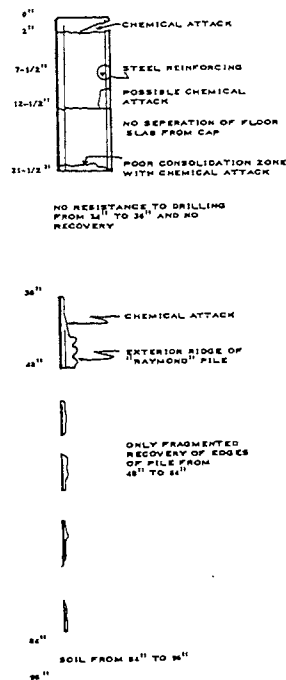
FIGURE 3

Most of the 43 cores showed evidence of severe deterioration, as indicated on Figures through 4, which indicate pictorially condition of representative cores. In general the deterioration was most severe between depths of 2 to 6 ft (0.6 to 1.8 m), with several cores recovering no concrete within this range. Some damage as high as 12 in. (30 cm) was also noted. At two locations, no soil was found below about 2 ft (0.6 m).
